Manhole Inspection Summary

Manhole # S71S__002MH

Insp Date: **4/18/08 10:35 AM**

Location Address: **6700 Railway Ave.**

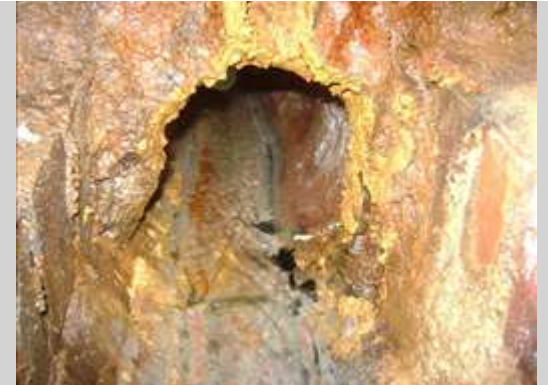
12 O'Clock Outflow

8 in. Circular Gravity Sewer
Pipe Out @ 12 O'Clock

Pipe Height: **8.4** (in.) Rod and Bar (Angled)
Pipe Material: **Clay** ☐ Pipe Lined
Invert Depth: **8.50** (ft.) Flow Characteristics: **Slow**
Deposits: ☒ None ☐ Mud ☐ Sludge ☐ Debris ☐ Grease
Silt Depth: (in.) Deposits Extent:
Infiltration: **None** Pipe Seal Cond: **Sound**

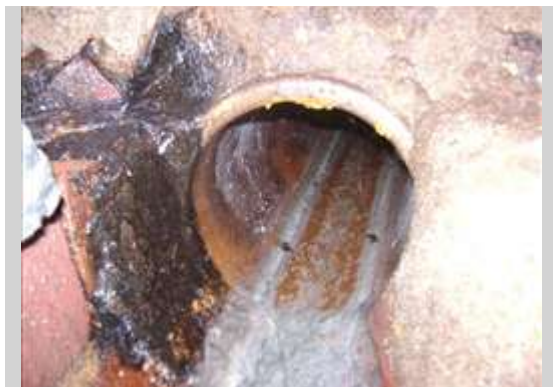
9 O'Clock Inflow

Pipe In @ 9 O'Clock

Pipe Height: **8.4** (in.) Rod and Bar (Angled)

Infiltration: **None** Pipe Seal Cond: **Sound**
